Gassing Fatality

MATLA COAL

23 April 2009

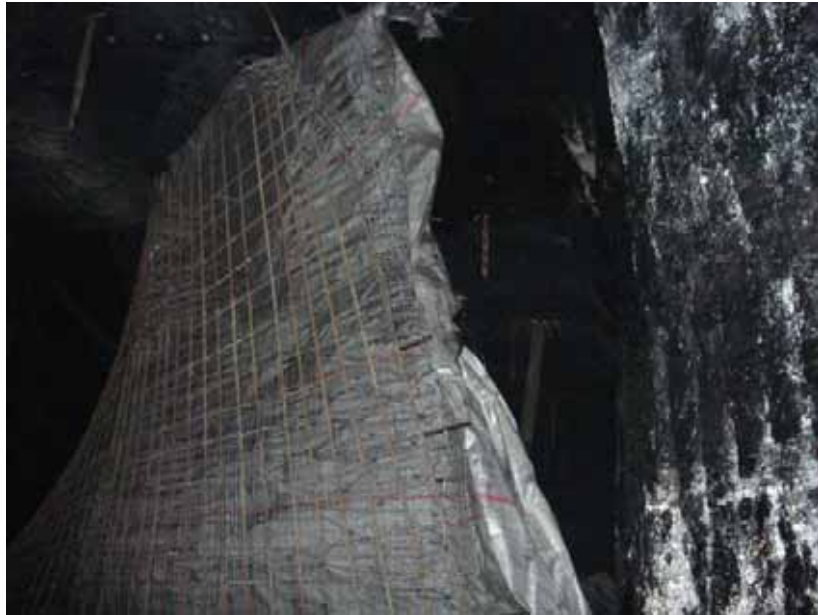
XX Photos of the damaged walls behind MG7

Third split after entering the water

- Spontaneous combustion occurred at 5 seam
- The initial goaf damaged two ventilation walls at panel 7 installation road allowing gas to escape into the workings
- An instruction not to enter the area where the incident took place was contravened by the miner and the team
- An effective barricade was not installed at the accumulation of water at panel 8 service road
- The contractor employees removed their self rescue packs in order to prevent water damage
- The contractor miner didn't have all the correct equipment to complete the work
- The specific area at panel 7 service road was not tested for gas before the crew were allowed to enter
- The miner was new in the area
- The contractor employees removed their self rescue packs in order to prevent damage
- Occupational Hygienist responsible for contractors but not responsible for declaring work areas safe to work

ISSUE	ACTION
Spontaneous combustion occurred at 5 seam	<p>Re-visit the goaf sealing strategy and investigate best practices.</p> <p>Install additional telemetry gas detectors around goaf bleeder road</p>
The initial goaf damaged two ventilation walls allowing gas to escape into the workings	<p>Complete 140 kPa walls to seal off goaf area.</p> <p>Purchase dual gas detection cap lamps for backbye pesonnel (including contractors).</p>
An instruction not to enter the area was contravened by the miner and the team	<p>Investigate a “Black box” recording telephonically and two way radio communication in the control room. Firemans report.</p> <p>Formal instruction system implemented.</p>
An effective barricade was not at the accumulation of water at panel 8 service road	<p>Access control to goaf bleeder road</p> <p style="padding-left: 40px;">Construct lockable barricade over the full road width with key control</p> <p>Purchase additional gas testing equipment for all operations</p>

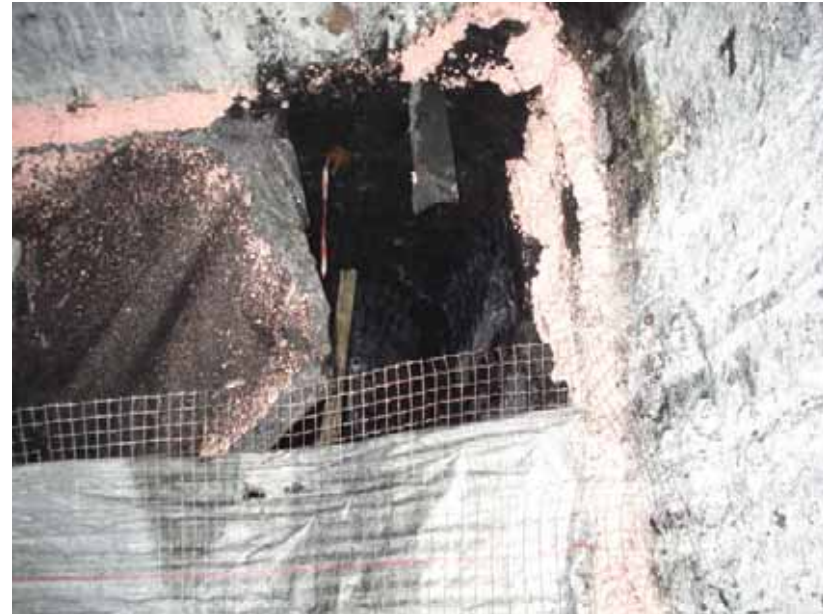
Fourth split after entering the water
