# **The Effects of Spontaneous Combustion on Safety, Health and the Environment at New Vaal Colliery**

**GJ Stenzel**

Assistant Manager  
New Vaal Colliery

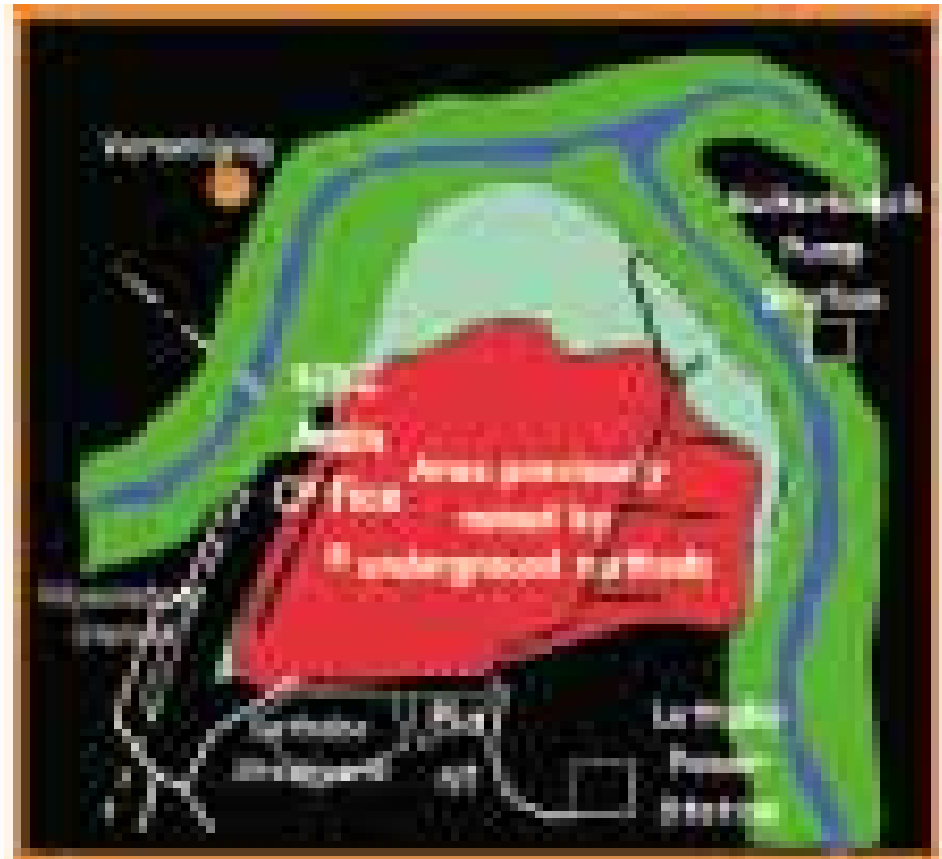
**Figure 2**  
**The areas where underground mining was carried out**

To create an environment in which spontaneous combustion can occur there must be a supply of oxygen. This is provided by the numerous openings into the old workings such as: the old workings exposed by mining the strip, geological drill holes, blast holes

which penetrate the old workings and the blasted material voids. These openings provide airflow and thus supply the oxygen needed for spontaneous combustion.

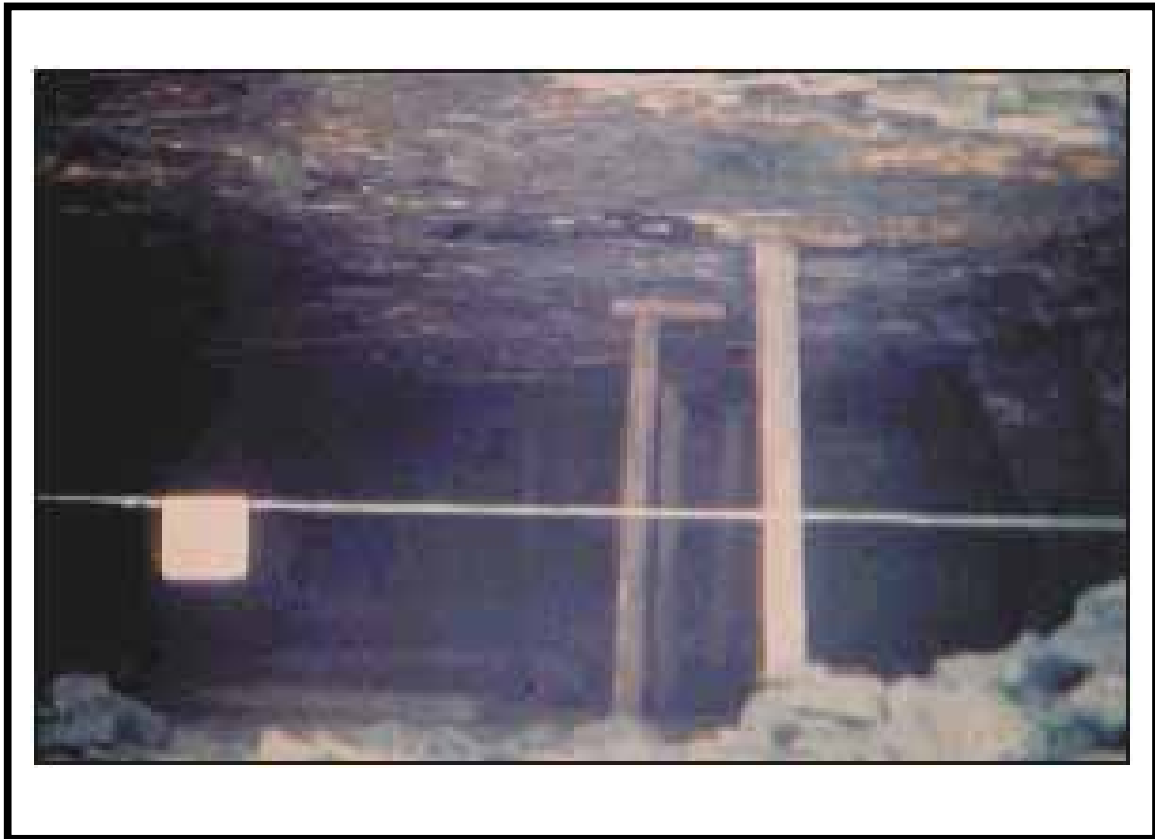
**Figure 4**  
**The conditions of the underground board and pillar workings**

Poor roof conditions, which are due to the closeness of the present opencast operation, exist. The roof has collapsed leaving cavities in the roof and this has allowed carbonaceous interburden to fall into the voids which again supports combustion. The area was mined largely before the introduction of mechanical roofbolts with the roof only supported using removable timber sticks. Crushing of the ribsides has occurred due to the age of the old workings and the poor safety factors used (Figure 4). This has left large quantities of fine coal exposed to oxidation.

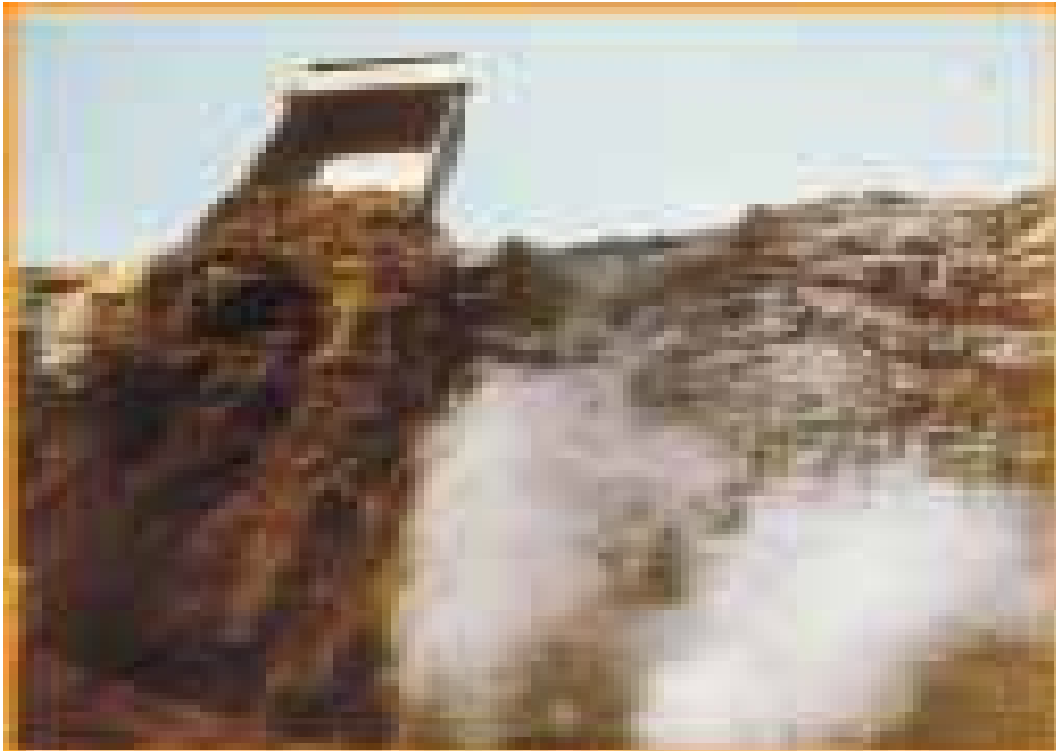
**Figure 7**  
**Sand being dumped over the highwall to seal off the old workings**

It was proposed that the mine should try to smother the fires using sand. Sand was tipped directly over the highwall above the old workings closing off the holings into the old workings (Figure 7). This did little to stop the spread of the fires and as the next cut was taken it was found that the fires had in fact advanced as far as 80 metres into the workings ahead of mining. It was realised that this option would never extinguish the fires and merely hid the fires from sight, which was a danger to personnel and equipment working on the benches above the fires.

Figure 7 showing sand being dumped over the highwall to seal off the old workings

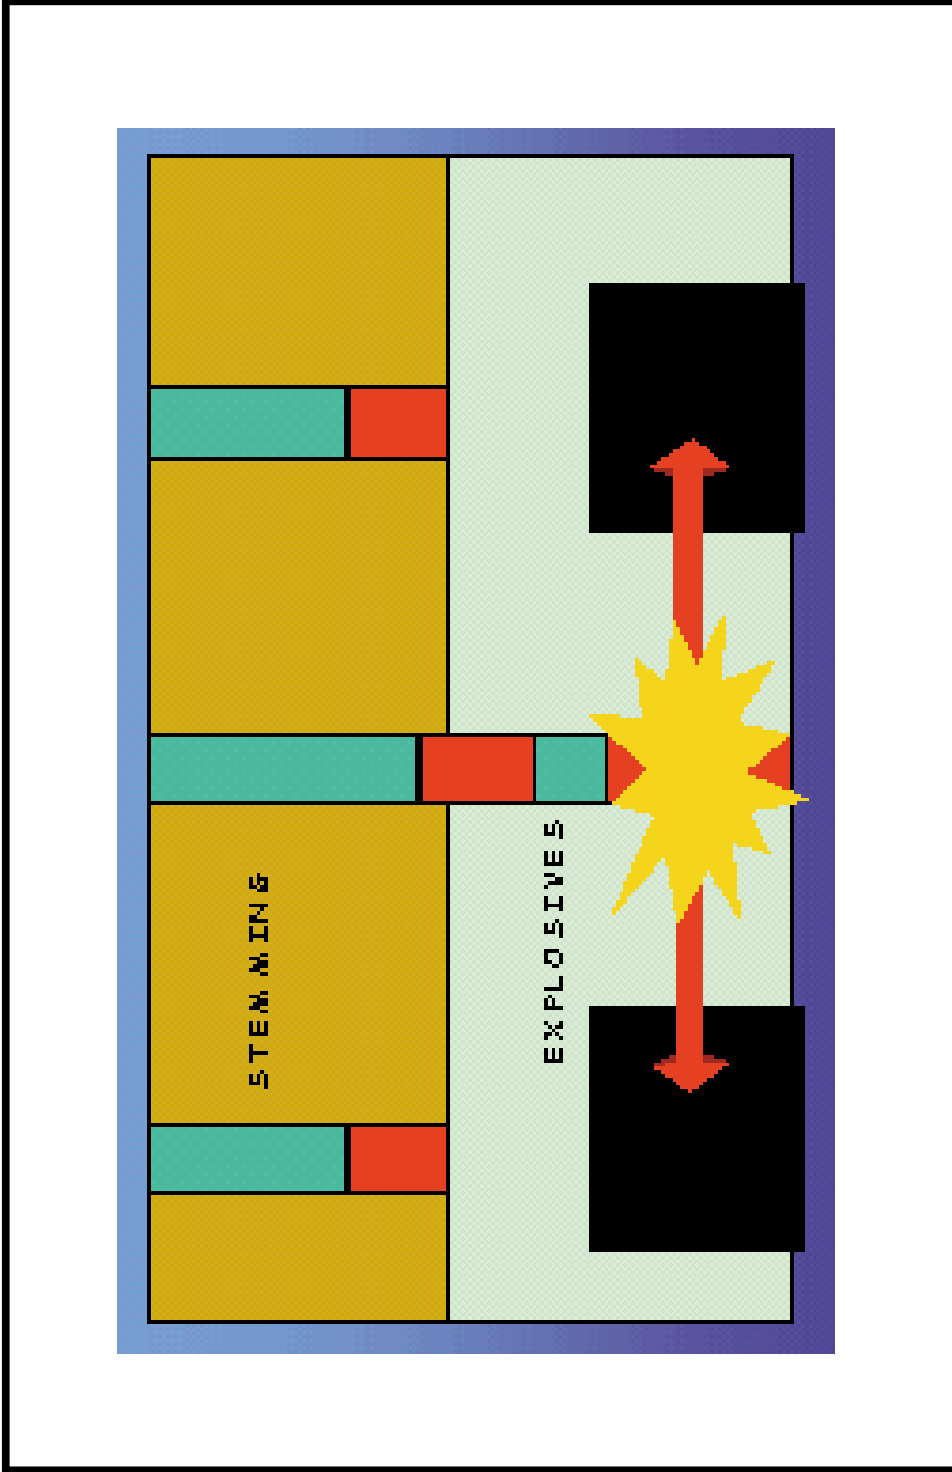
In May 1993 it was decided to stop all pre-splitting and to buffer blast the areas where the fires were raging in the underground workings. Buffer blasting is a technique where the coal pillars are totally destroyed by placing large charges in the pillars and the roof above the bords (Figure 9). This totally seals the entrance to the workings thus preventing air from entering the workings.

**Figure 9 showing the schematic layout of a buffer blast in section**

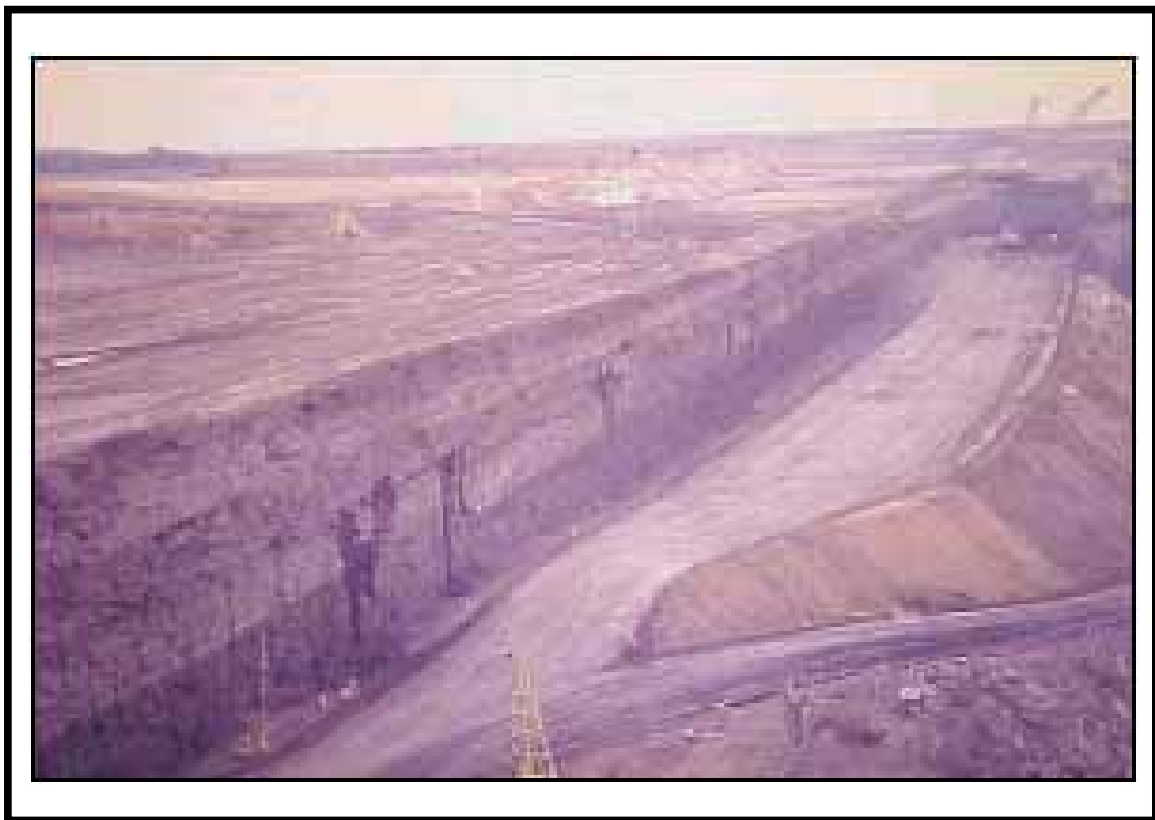
**Figure 11**  
**The effects of buffer blasting and sand dressing**

The buffer blasting alone was not adequate to eliminate the fires and, in addition to the buffer blasting, sand dressing of the highwalls is common practice (Figure 11). This is currently our simple yet most effective treatment of spontaneous combustion fires at New Vaal.

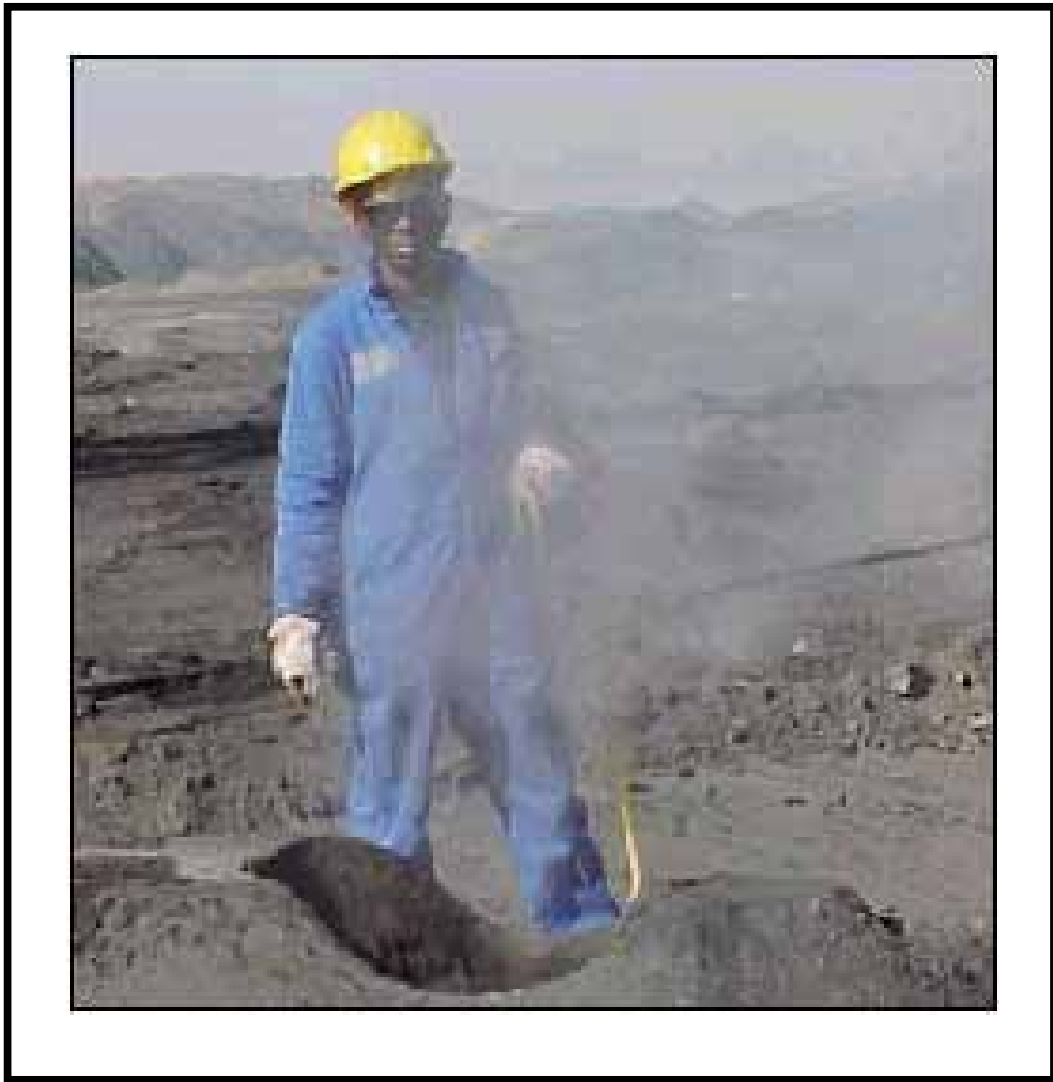
**Figure 12**  
**Measuring temperature of fire in a drill hole.**

Blasting of areas, which contain fires, is a safety risk and therefore all holes are checked for temperature before being charged with explosives.(Figure 12). Standard procedures are in place that all holes are checked, temperatures measured and logged before charging up can take place. No blasts are held over and all blasts are blasted on the same day as soon as they are charged up.

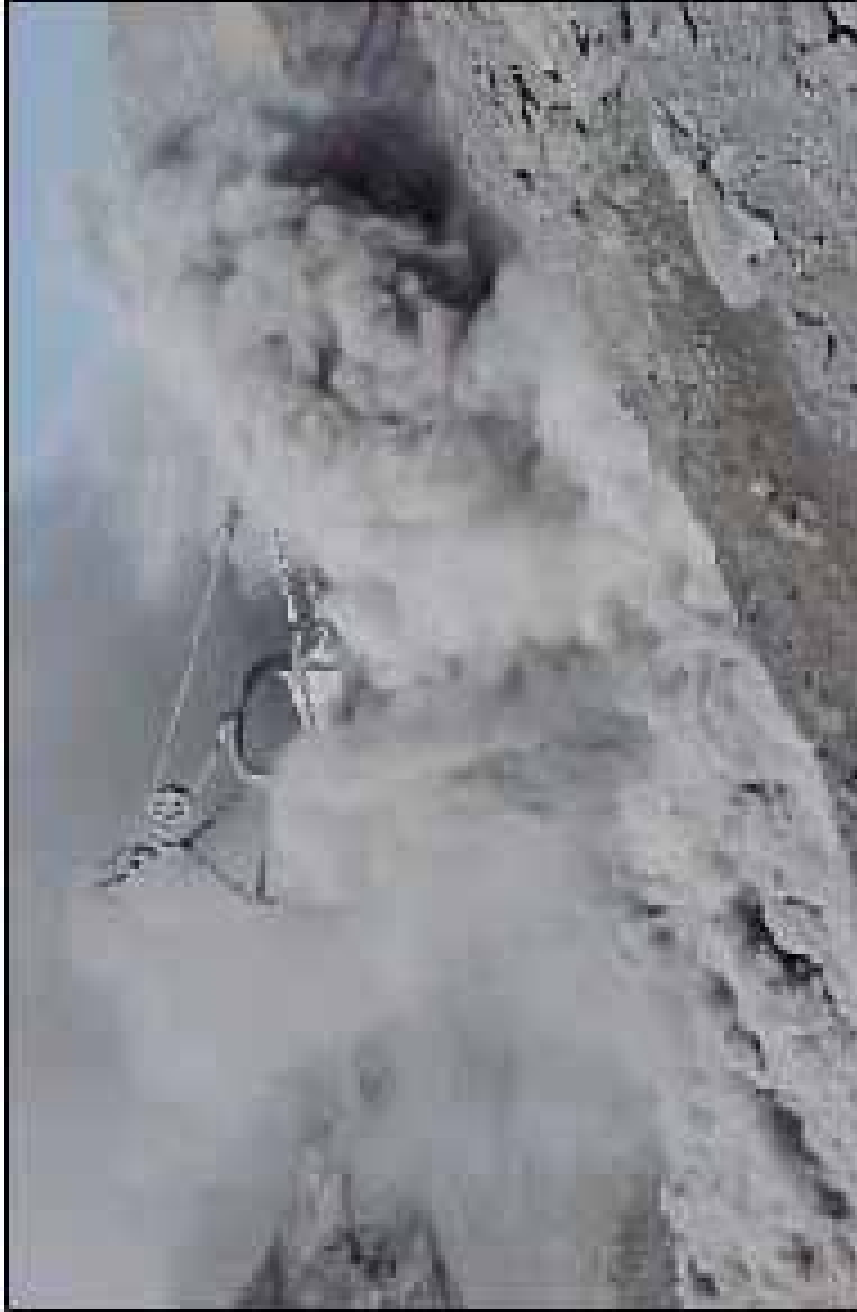
**Figure 13**  
**The dragline loading out burning material.**

The dragline operation is not at risk when it loads out the fires (Figure 13).

The operators and ground staff remain in the machine during this operation. Dust and fumes pose a health risk, which will be discussed later. When a dragline bucket has been working in fires then it is dangerous to work on the bucket before it has cooled off, eg changing of tips and adaptors.

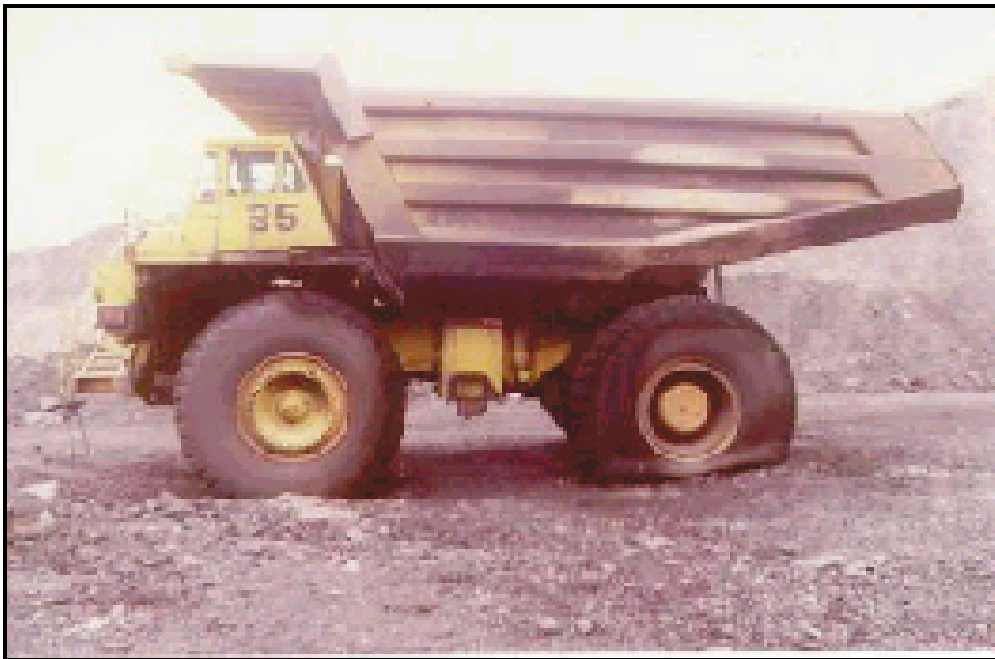
**Figure 14**  
**The tyre damage caused by continuous loadng of burning coal**

Loads the burning coal and ash to the tip. The greatest danger is to persons on the ground, who are not permitted within a 150m radius of the shovel when loading burning coal. Using the truck dispatch system has helped to rotate the trucks that load the burning coal as it prevents the tyres from overheating and catching fire. (Figure 14) Sand is also tipped in the face to cool down the floor. One instance of tyre damage has been recorded where a truck was assigned exclusively to a shovel loading burning coal and the tyres caught fire. Wheel loaders are not permitted to load from burning faces.

Figure 14 showing the tyre damage caused by continuous loading of burning coal

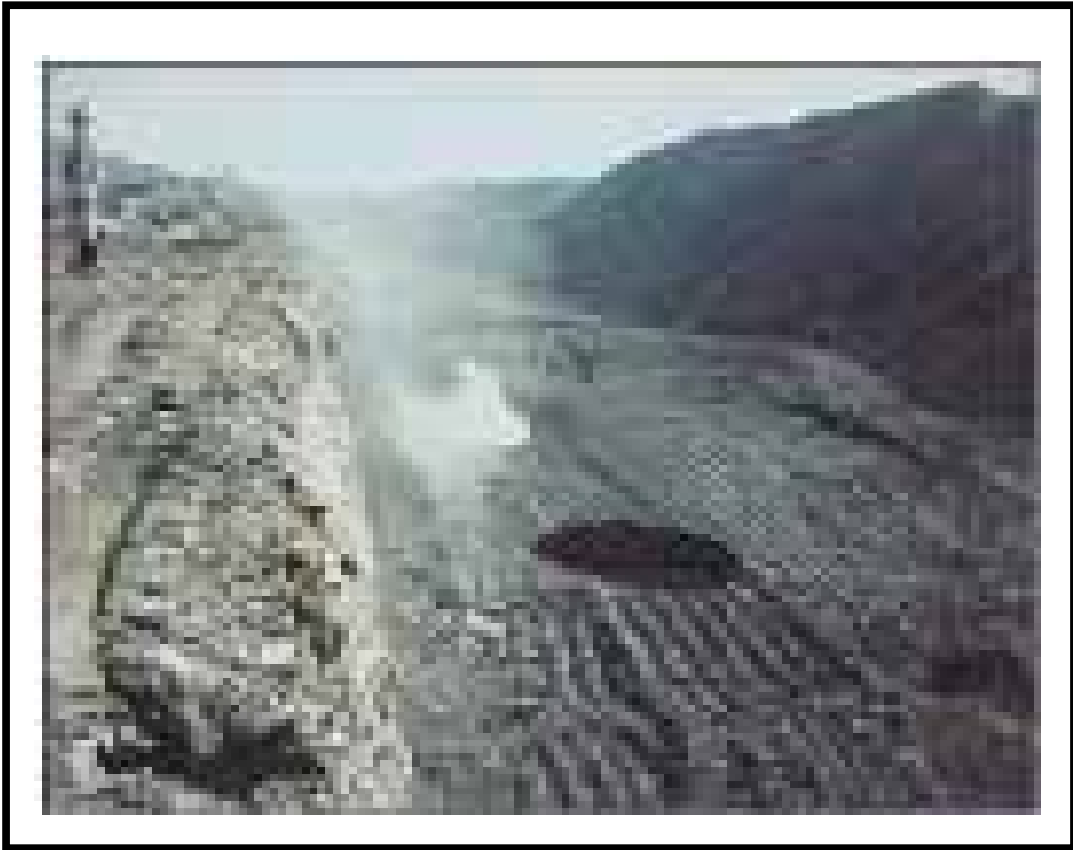
**Figure 15**  
**The collapse of burning bords after the dragline has exposed coal**

Only track dozers are used to push burning coal and ash. Wheel dozers are kept away from the faces except to push sand. Once a dragline has exposed coal track, dozers are not put onto the coal to clean as it is too dangerous and the roof of the bords can collapse (Figure 15).

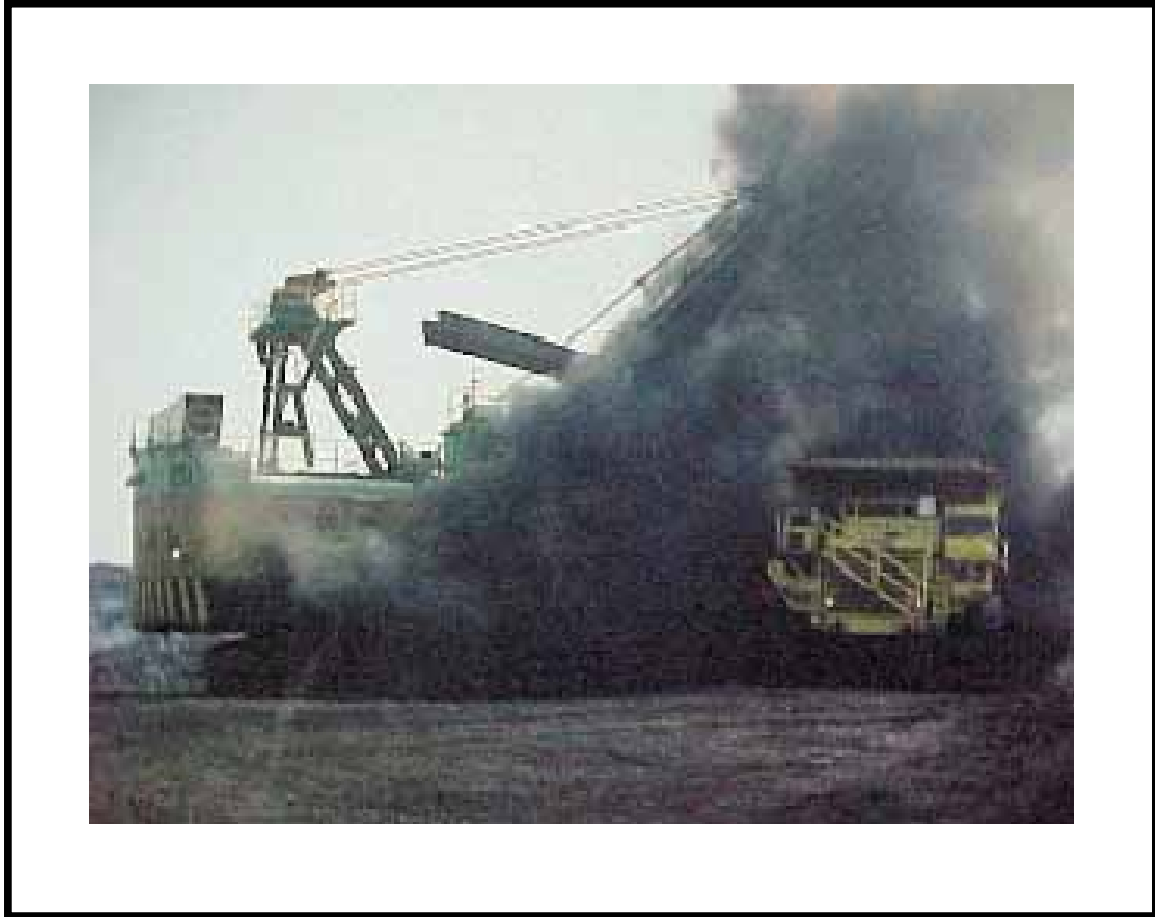
**Figure 16**  
**The dust associated with the loading of burning coal.**

Associated with spontaneous combustion is excessive dust from the coal and ash (Figure 16). New Vaal's coal is the poorest quality bituminous coal burnt in a thermal power station in South Africa with an average of 39,5% ash. The ash has a high silica content of some 50% which has the potential to cause long term damage to the health of the employees if it is not controlled. Respirable dust sampling is an ongoing process and a gradual improvement in the measurements has been seen as the incidence of spontaneous combustion was reduced and brought under control. Respirable dust sampling is done using a gravimetric dust sampling pump (Figure 17) carried by the employee for a full eight hour shift. Measurements are carried out in accordance with the Minerals Act and all exceptions (readings greater than 2,0 mg/m<sup>3</sup>) are investigated and reported.

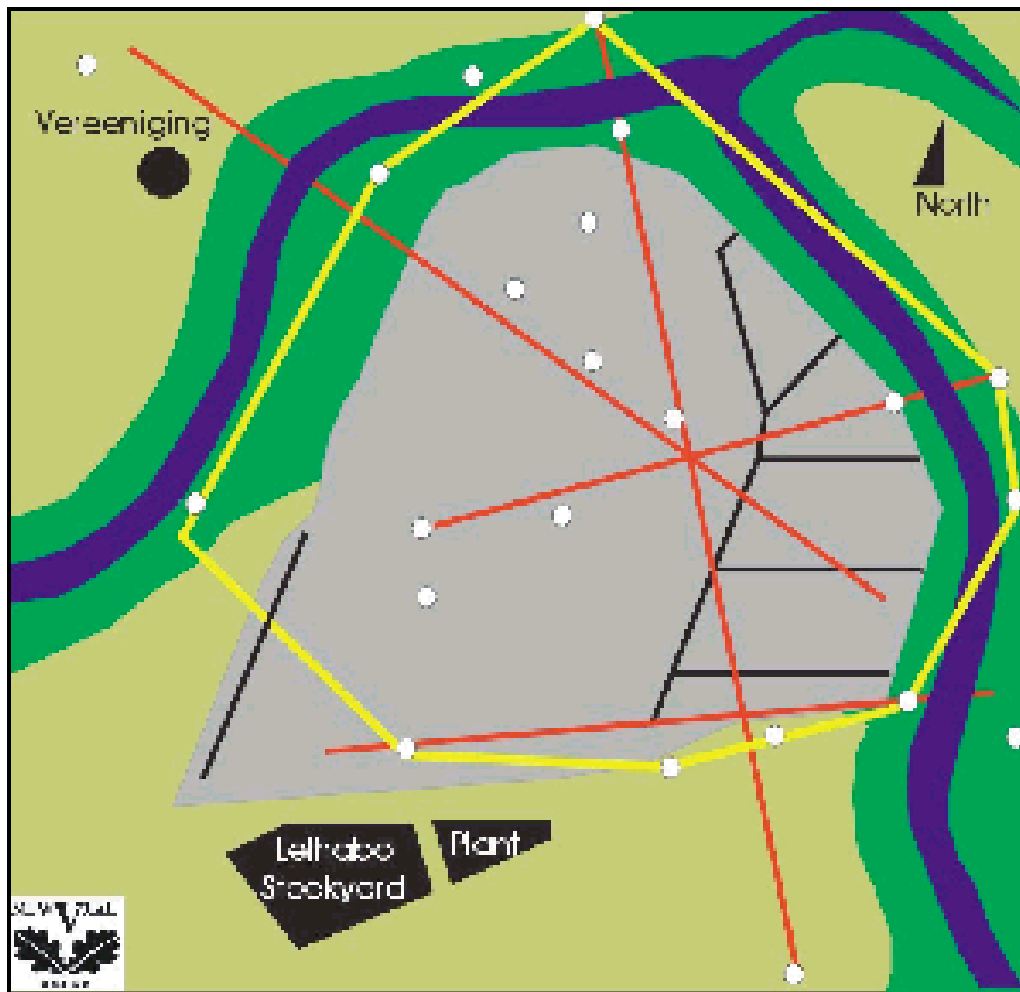
**Figure 18**  
**The dust monitoring sites at New Vaal and predominant wind directions**

To measure the impact of mining activity on coarse dust production and fall-out, dust monitors are located within the mine area and in Vereeniging and its residential suburbs (Figure 18).

Two types of dust collection buckets are used : open buckets, which lie in lines through areas of sensitivity, and wind direction buckets, which surround the colliery area. The latter determines the import and export of dust at the colliery. Wind directions and velocities are also recorded using cup anemometers. The twin-bucket wind directional system (Figure 19) was specifically designed for conditions at New Vaal Colliery. It has since been accepted by the Department of Environment and Tourism as a standard means of measuring dust fall-out. These monitors are now being utilised by government departments and other mining concerns.

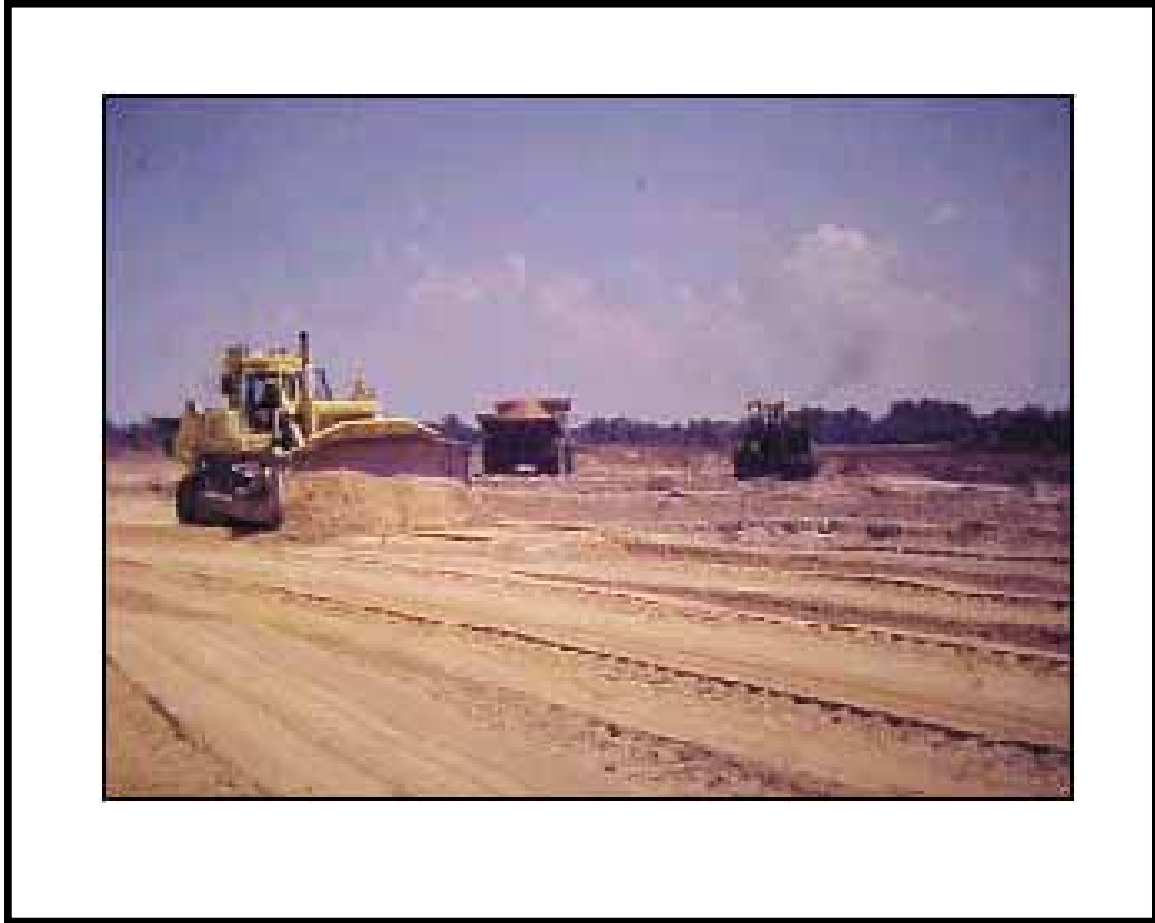
**Figure 21**  
**The leveled spoils with sand being placed.**

A major environmental threat of spontaneous combustion is to have burning rows of spoils. In order to minimize this threat New Vaal Colliery has adopted a system of highwall access ramps as opposed to the usual low wall access ramps found in strip mines. Highwall ramps allow for the rehabilitation of the spoils to be completed right up to the edge of the mining window, without any ramp scars, thus preventing oxygen ingress. Once the spoils have been leveled, New Vaal places 1,25m of sand over the shaley spoil material which effectively seals off any voids through which oxygen could enter to propagate spoil fires. (Figure 21). This has been 100% effective and the rehabilitated area of some 481 ha shows no signs of any heating or combustion.
