Gassing Fatality

MATLA COAL

23 April 2009

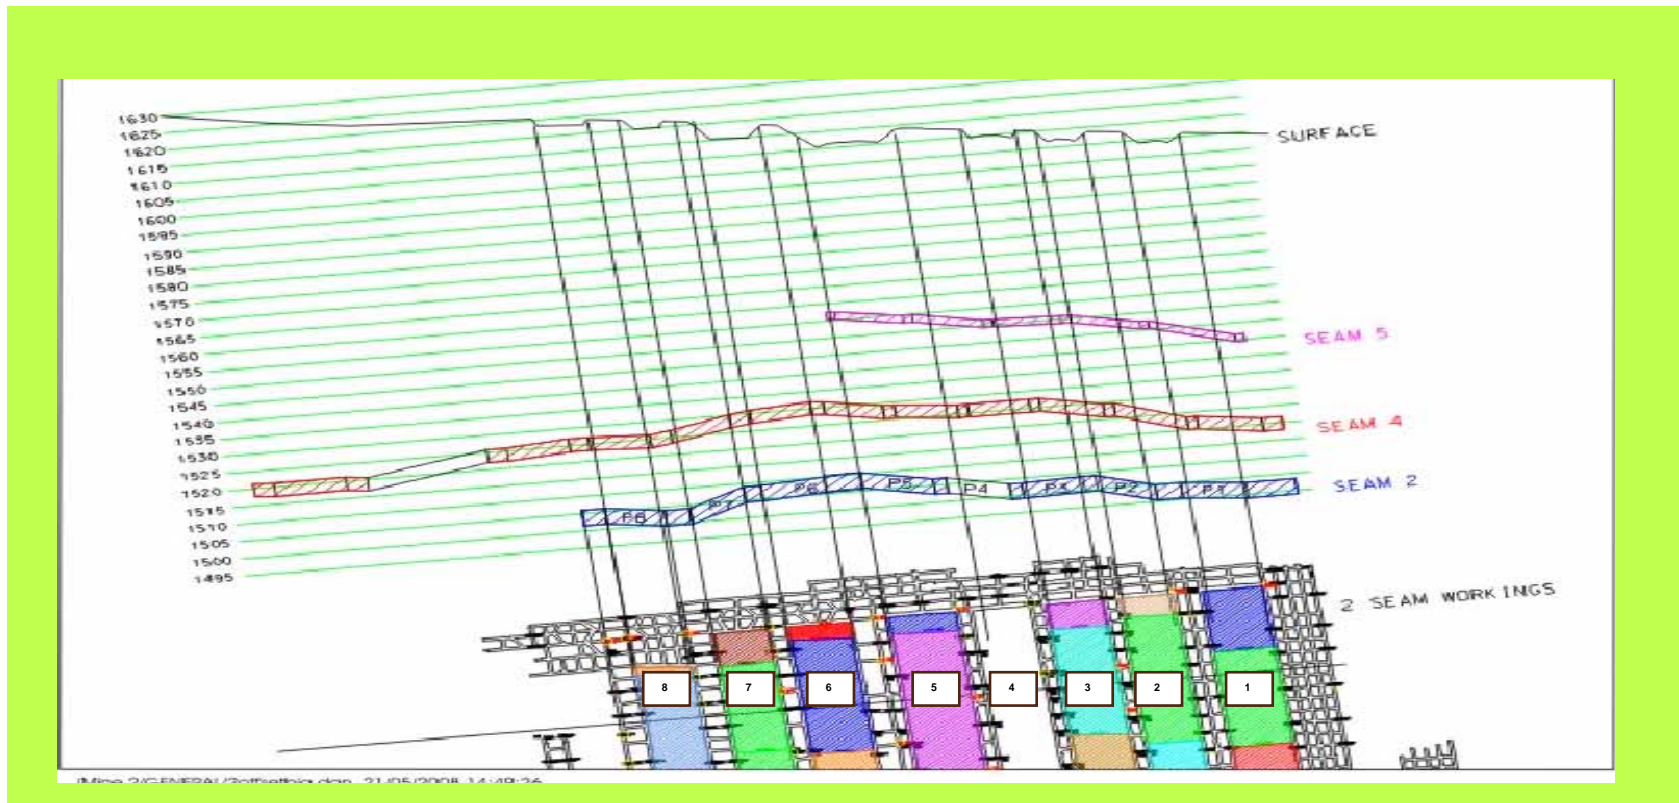
In 2002 short wall mining started on 2 seam. At this stage 5 seam and 4 seam were already mined out. Initially the 2 seam panels were not superimposed with the 4 seam panels. This resulted in abnormal face pressures which resulted in numerous face breaks. A decision was then taken to superimpose 2 seam and 4 seam as from panel 6. This resulted in major subsidence and surface cracks. No CO gas was detected during the mining of the first five panels over a time period of four years
